# Inspection Report

123 Sample St.

## **In-House Inspections**

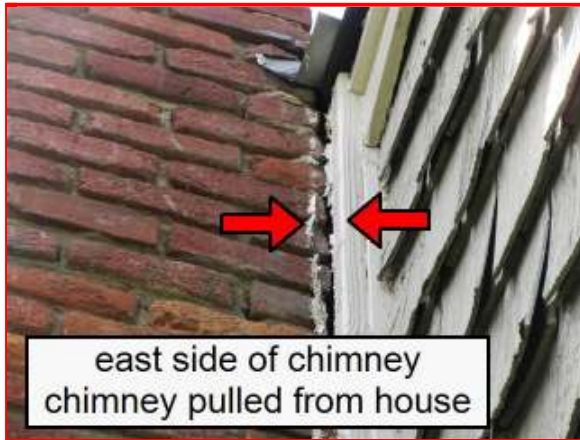
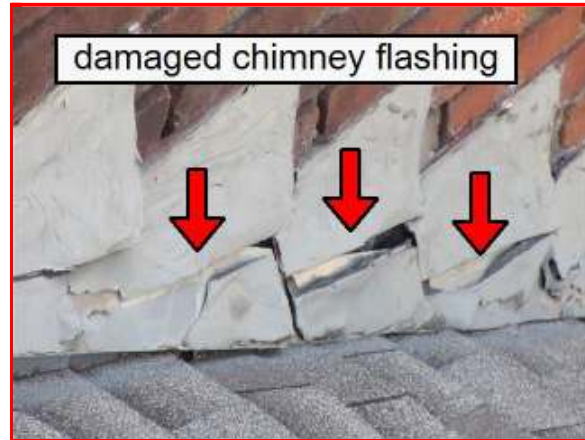
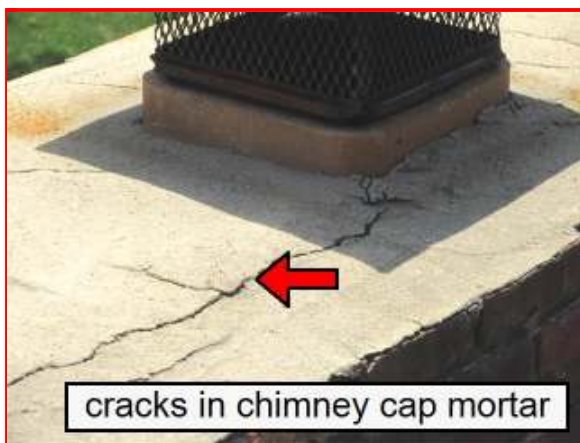
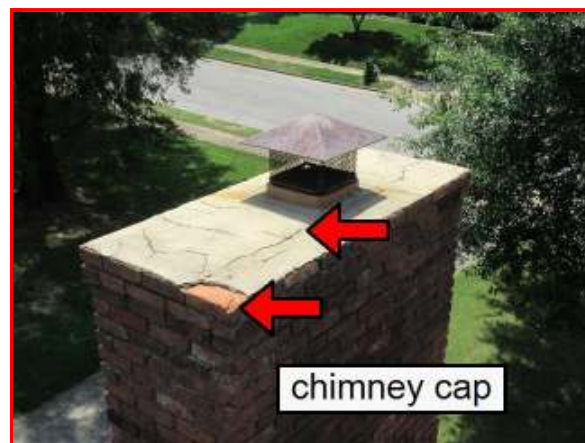
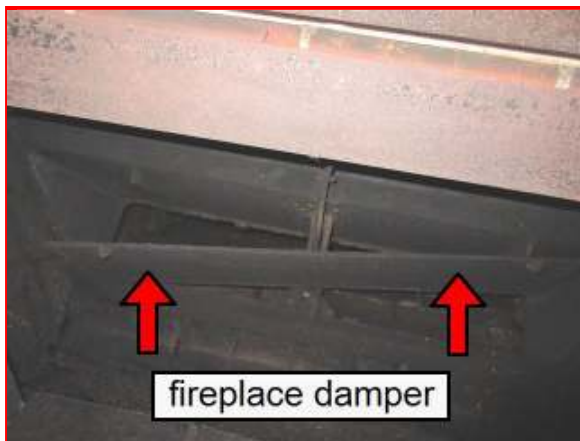
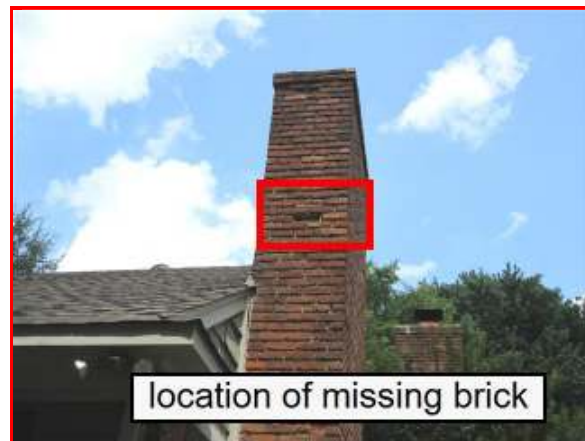
Chimney structure has settled on its foundation and has pulled away from house causing gaps between chimney brick and house siding. Chimney flashing on roof has pulled loose. Top cap on chimney has cracks and chips in mortar covering. Brick on west side of chimney has fallen out. Damper inside chimney will need repair, damper will not close. Possible jacking of chimney back in place and new foundation poured for support will be needed to repair chimney. Consult structural engineer and or a chimney sweep for advice.

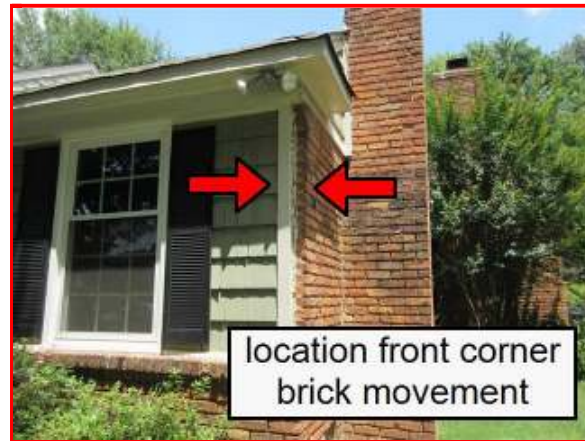
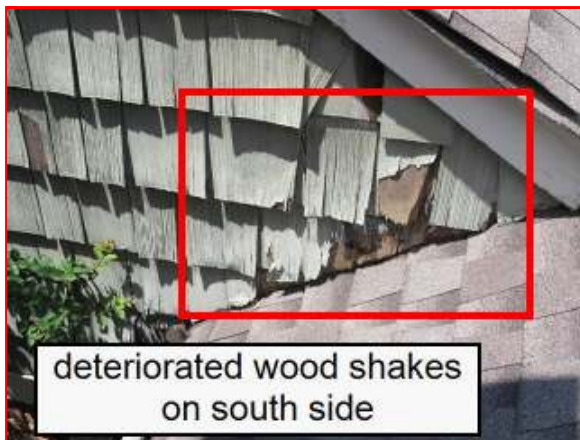
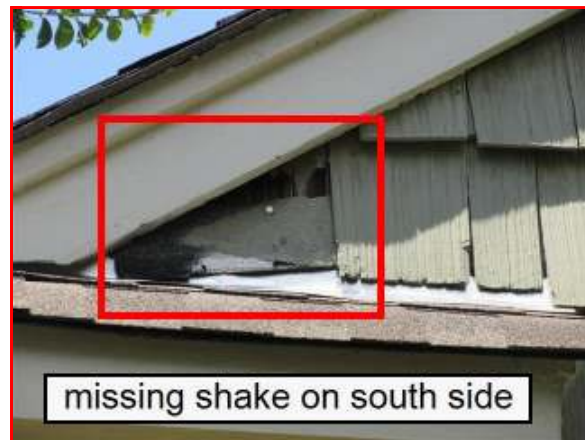
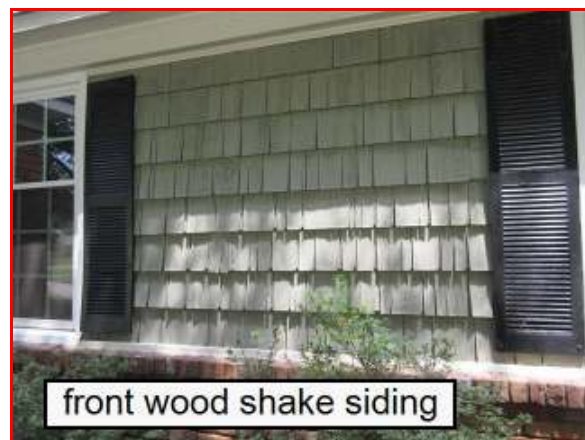
(1) Brick wall T front south corner of house has pulled from corner. Possible that chimney movement has pulled brick wall from front corner.

Wood shake wall shingles on front of house and on south side of house on second floor needs repair/replacing. Wood shakes are cupping, warping, pulling loose. Tree limbs are pushing under shakes on south side. Shakes on south side are deteriorated where they meet with roof.

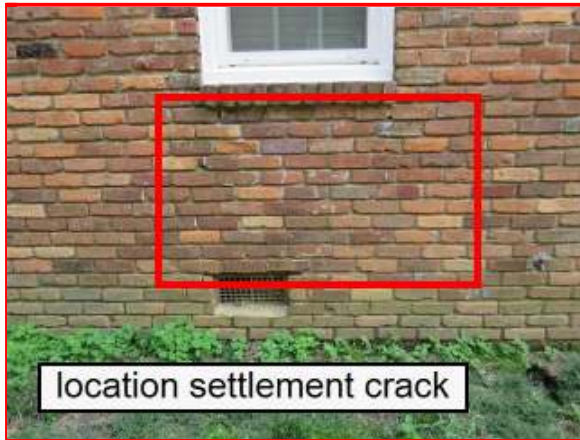
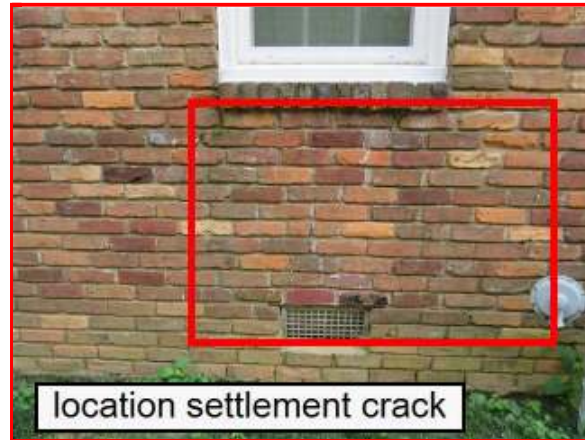
(2) There are small settlement cracks in exterior wall on north side of house. Normal settlement.

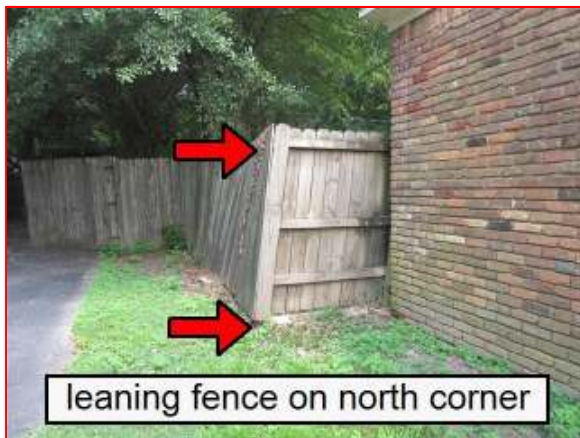
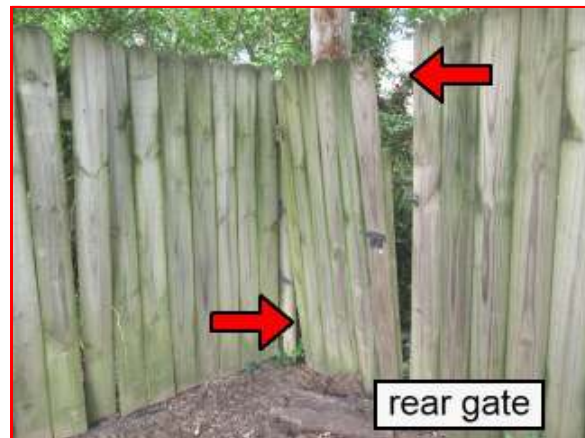
North side fence at rear corner of house is leaning. Post are not supported. Wood gate at rear north corner of fence is pulled loose at hinges. Several fence boards are loose, need nailing back in place. South side metal gate will not latch closed.

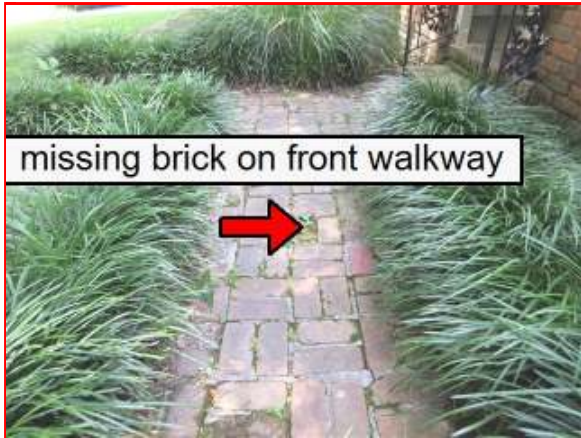
2.4 Item 1(Picture)

Front brick walkway has bricks missing that could cause trip hazard.

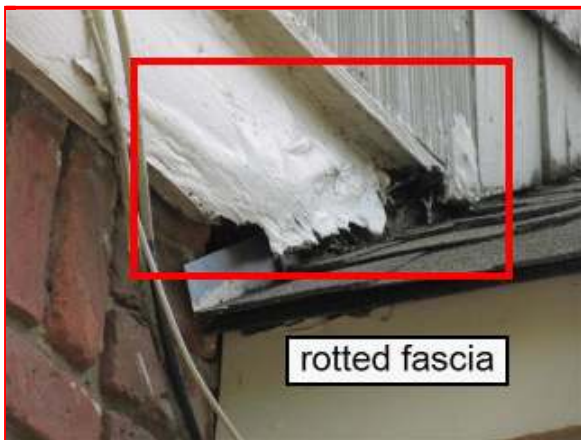
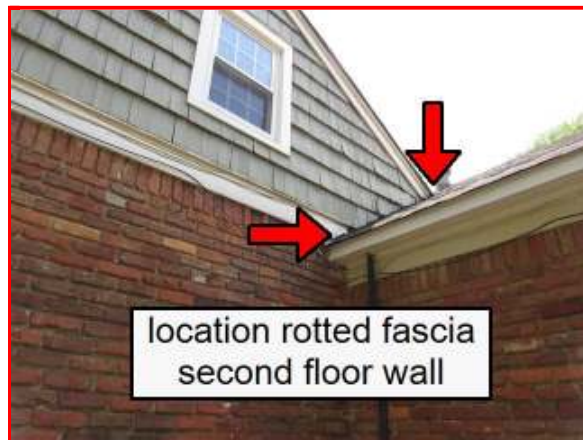
Fascia boards are rotted on second floor north side wall where boards are close to roof.

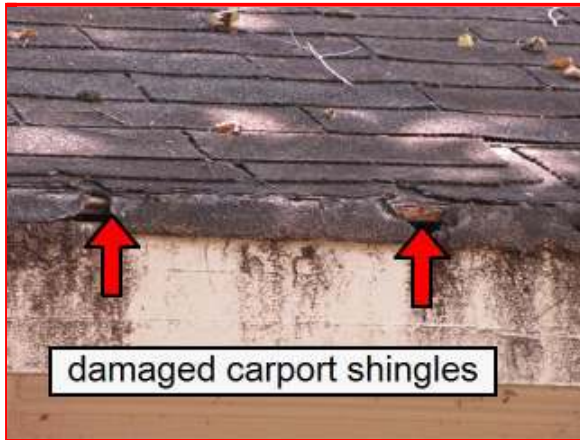
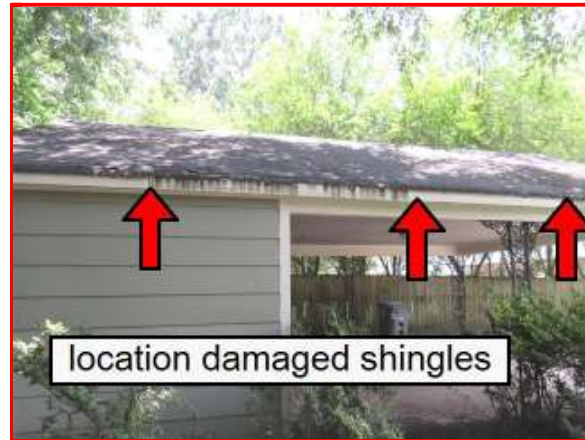
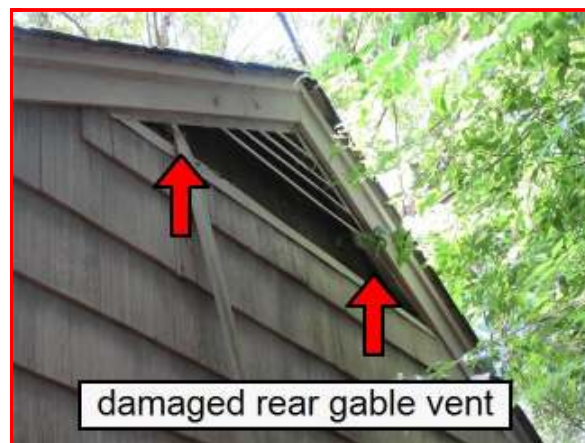
(1) Roof on carport has damaged shingles on north side with wood decking visible. Roof is old and in need of repair.

Gable vents are damaged on each end of carport. Vents need replacing.

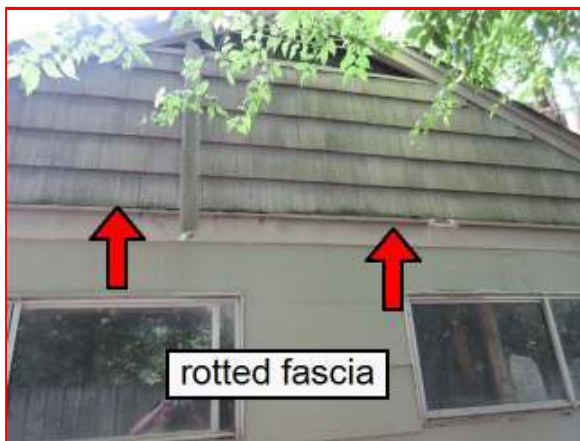
(2) Rear fascia and drip ledge on carport needs repair. top of fascia is rotted at drip ledge.

Carport door chewed on where rodents have entered utility room.

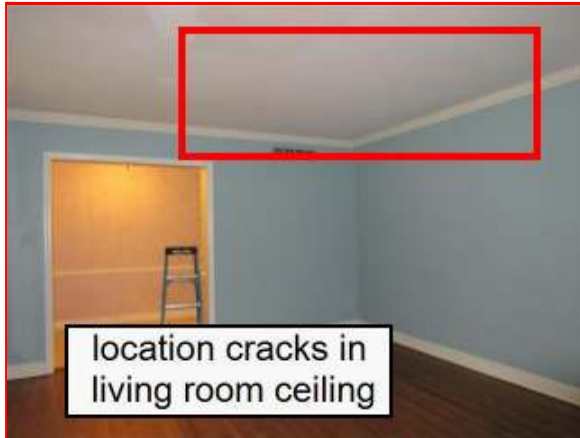
3.0 Item 1(Picture)

Ceiling in living room and hall have cracks from someone stepping on ceiling from attic.

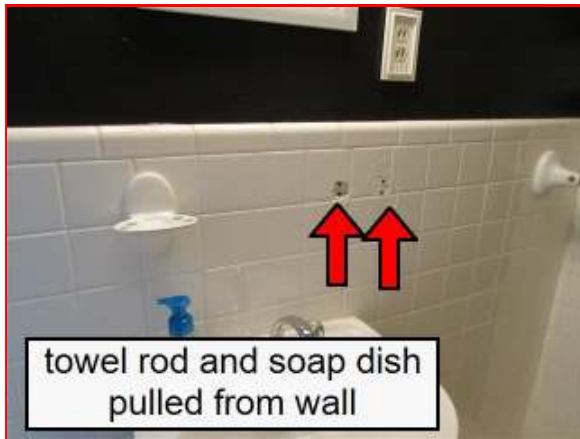
3.1 Item 1(Picture)

Towel rod holder and soap dish are pulled from wall in second floor bathroom.

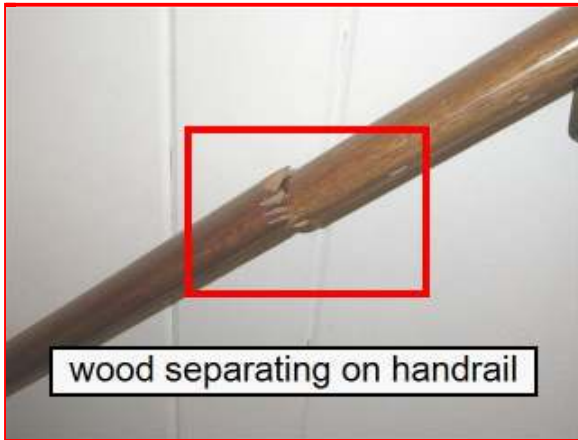
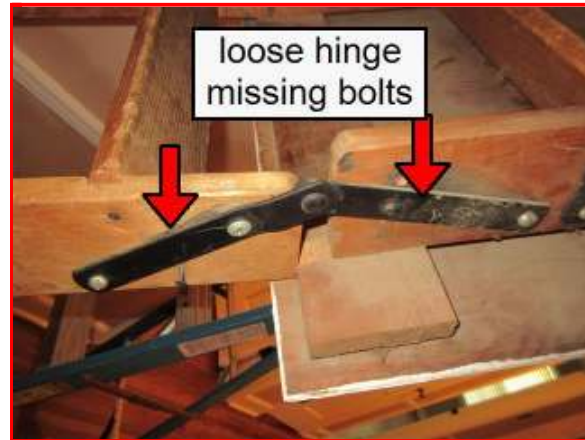
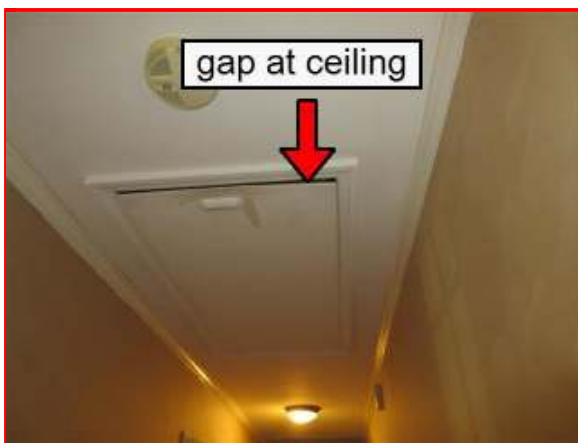
Hand railing in second floor stair well is damaged. Wood hand rail is separating.

Pull down attic stairs need repair. Hinges are loose with missing bolts. Stairs will not close completely, gap at ceiling when closed. Stairs are unsafe to climb.

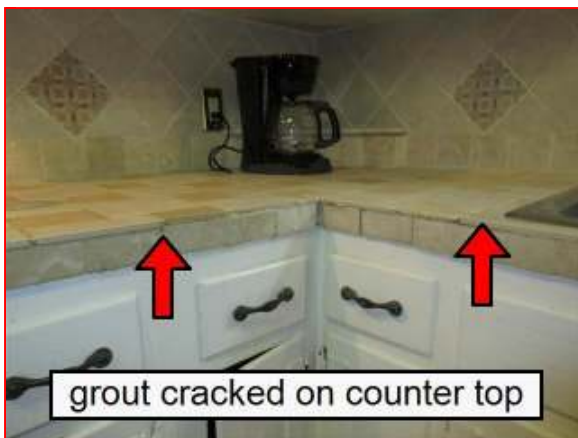
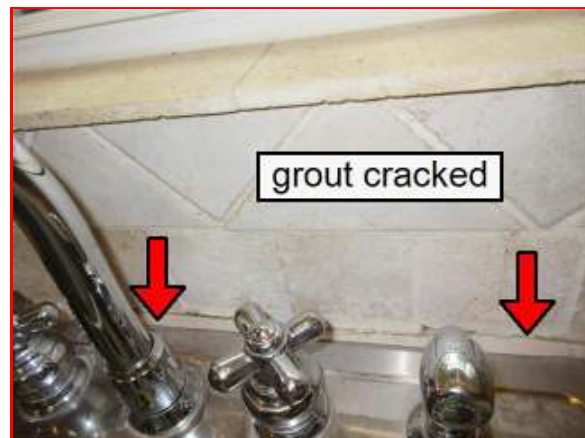
Grout is cracked on kitchen tile counter top. Hinges are sprung and kitchen cabinet doors will stay closed.

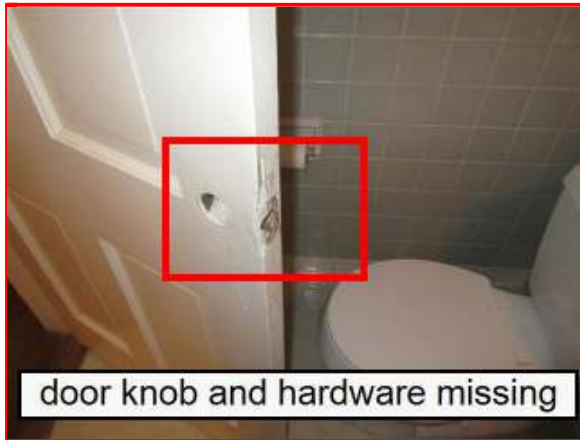
3.5 Item 1(Picture)

Door knob and hardware missing on second floor bathroom door. Hinges are not attached to wall cabinet door in second floor bathroom.

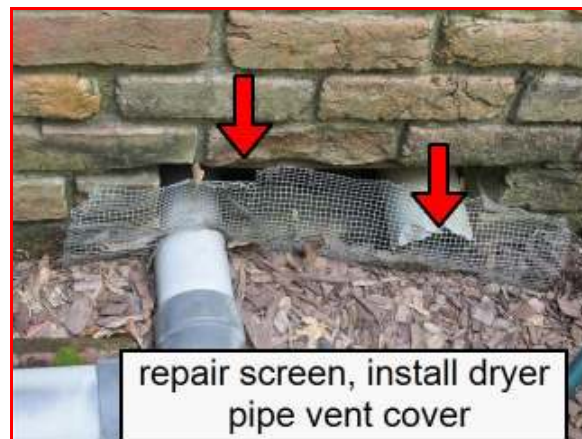
Soil is muddy under house. Rain water is penetrating foundation and accumulating under house. Lack of gutters is probably main reason for water intrusion under house. Vapor barrier is deteriorated. Recommend moisture remediator be consulted on ways to elevate water intrusion. Gutters and vapor barrier will help to keep moisture from damaging wood structure.

Water waste pipe and dryer vent pipe exit through foundation wall. Screen is pulled loose around pipes. Rodents can enter this area. Repair screen and install vent cover on dryer pipe.

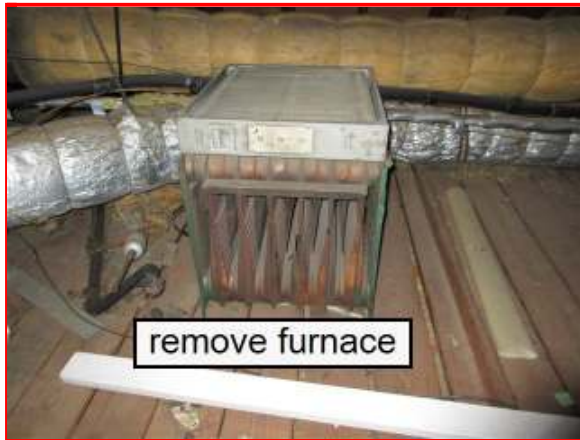
7.0 Item 1(Picture)

There is an old furnace in the attic.

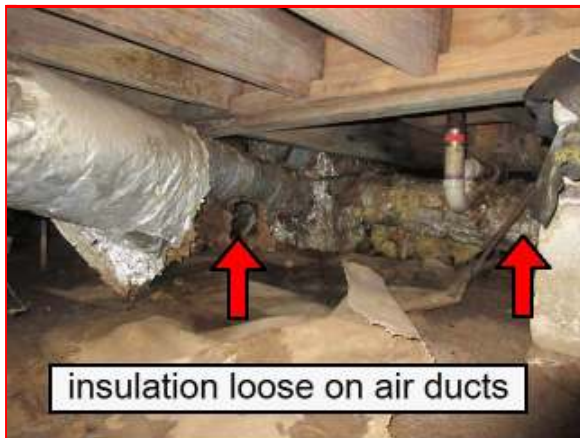
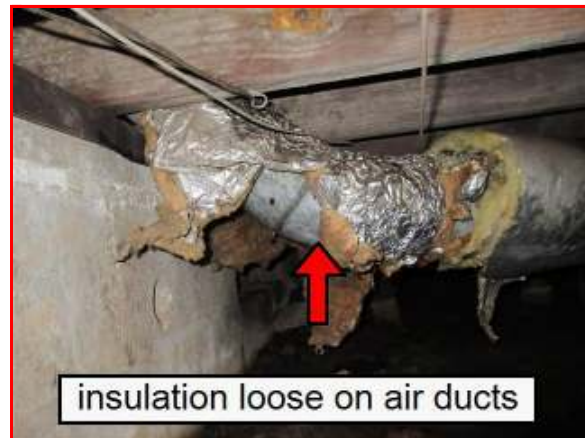
Insulation has been pulled loose in several areas of air duct under the house.

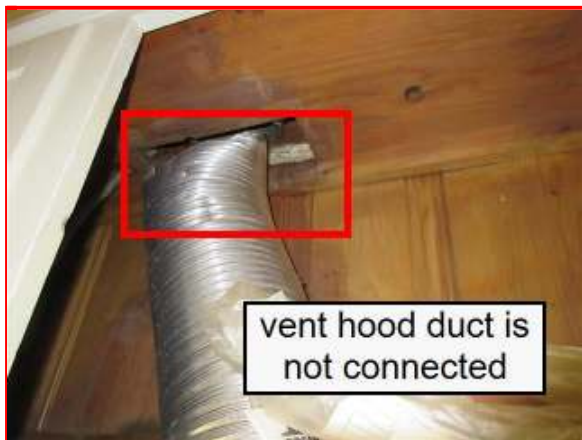
9.2 Item 1(Picture)

Kitchen vent hood ducting is not connected to pipe in upper cabinet.

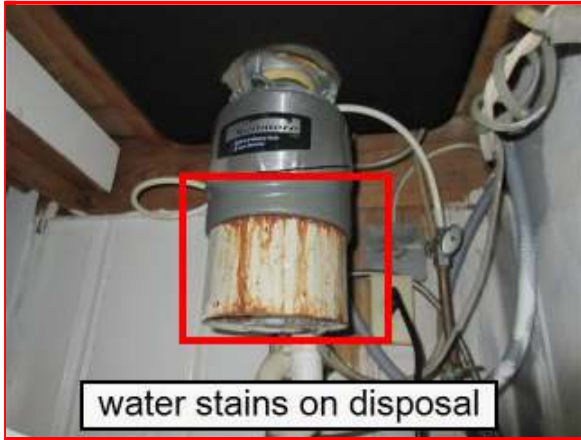
9.4 Item 1(Picture)

Disposal has debris in unit and locks up when using. Water stains on housing may be from leaks at some time when using unit.

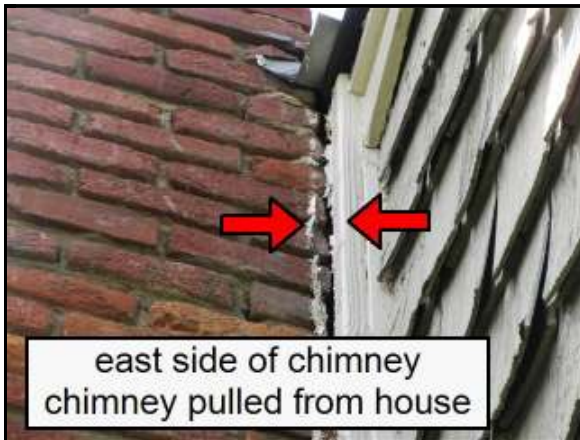
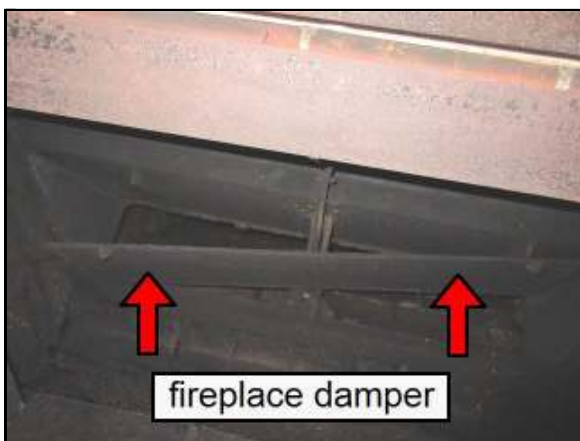
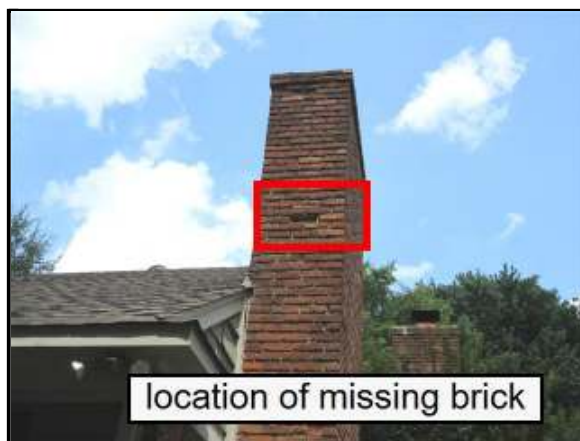
**1.2** Chimney structure has settled on its foundation and has pulled away from house causing gaps between chimney brick and house siding. Chimney flashing on roof has pulled loose. Top cap on chimney has cracks and chips in mortar covering. Brick on west side of chimney has fallen out. Damper inside chimney will need repair, damper will not close. Possible jacking of chimney back in place and new foundation pored for support will be needed to repair chimney. Consult structural engineer and or a chimney sweep for advice.

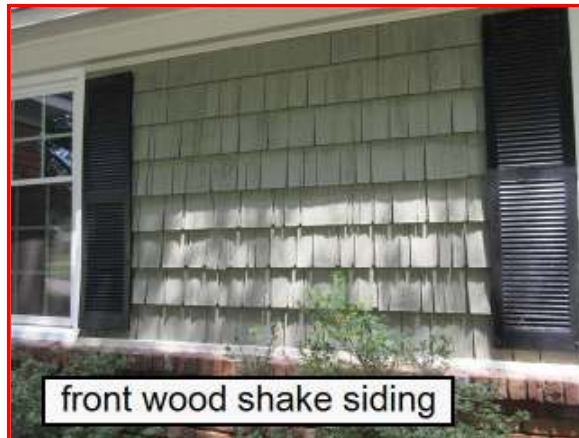
📍 **2.0** (1) Brick wall T front south corner of house has pulled from corner. Possible that chimney movement has pulled brick wall from front corner.

Wood shake wall shingles on front of house and on south side of house on second floor needs repair/replacing. Wood shakes are cupping, warping, pulling loose. Tree limbs are pushing under shakes on south side. Shakes on south side are deteriorated where they meet with roof.

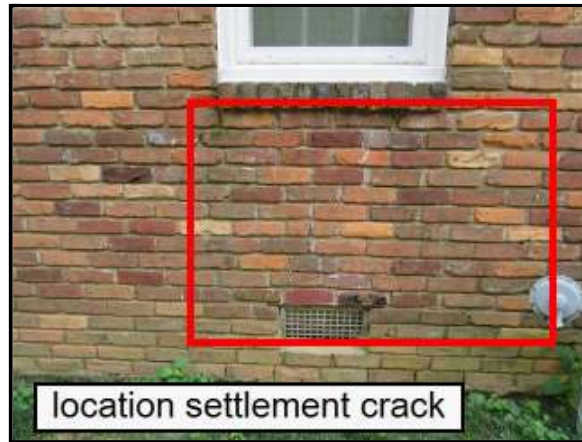
📍 **2.0** (2) There are small settlement cracks in exterior wall on north side of house. Normal settlement.

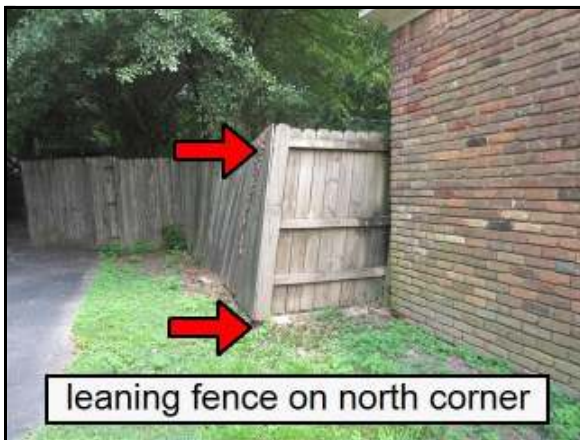
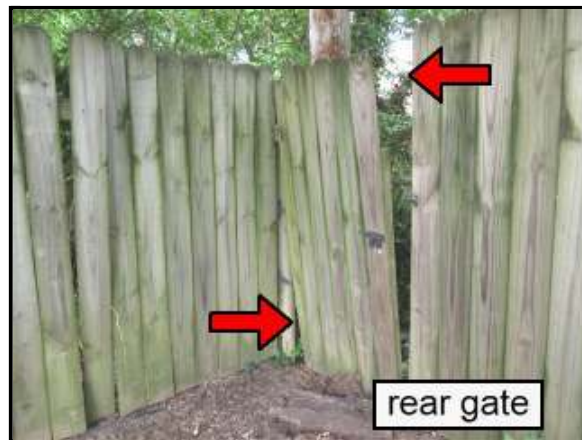
📍 **2.3** North side fence at rear corner of house is leaning. Post are not supported. Wood gate at rear north corner of fence is pulled loose at hinges. Several fence boards are loose, need nailing back in place. South side metal gate will not latch closed.

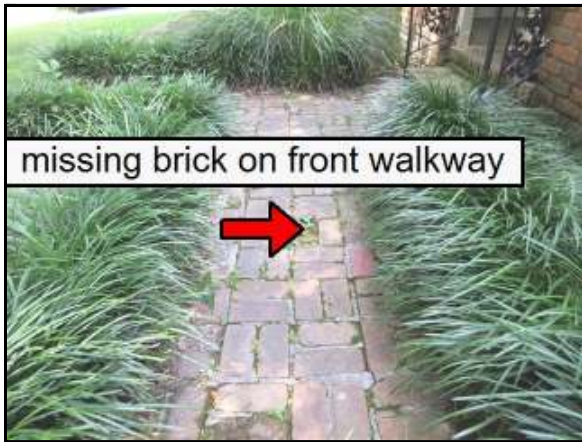
2.4 Item 1(Picture)

📍 2.4 Front brick walkway has bricks missing that could cause trip hazard.

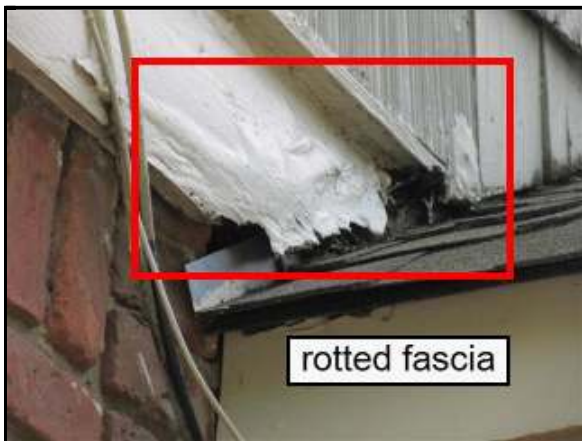
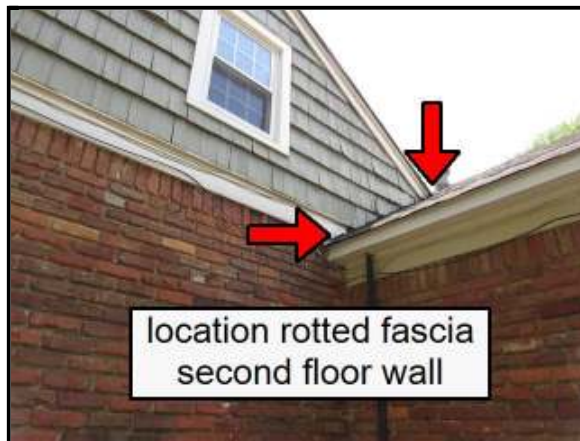
📍 2.5 Fascia boards are rotted on second floor north side wall where boards are close to roof.

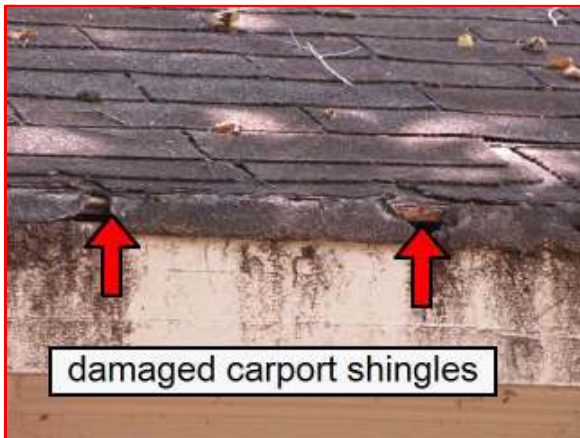
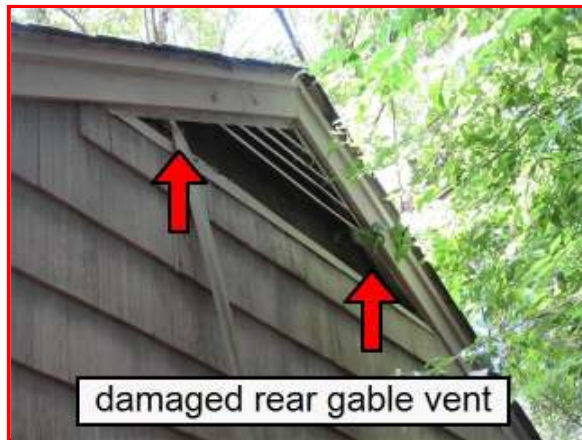
🏠 **2.6** (1) Roof on carport has damaged shingles on north side with wood decking visible. Roof is old and in need of repair.

Gable vents are damaged on each end of carport. Vents need replacing.

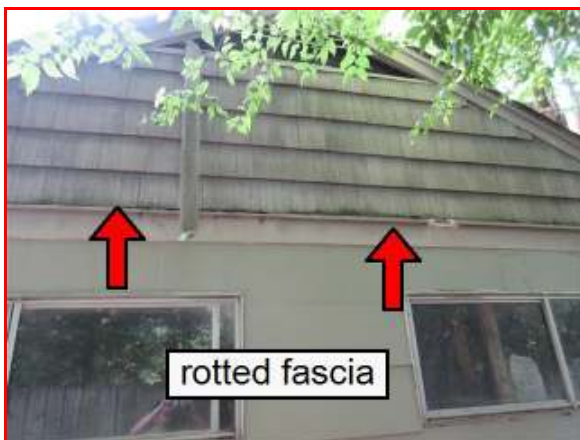
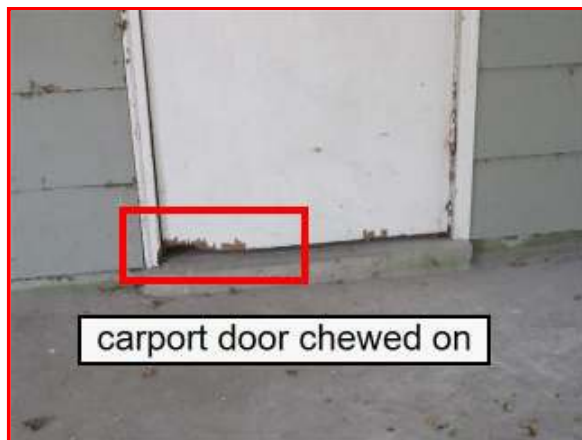
🏠 **2.6** (2) Rear fascia and drip ledge on carport needs repair. top of fascia is rotted at drip ledge.

Carport door chewed on where rodents have entered utility room.

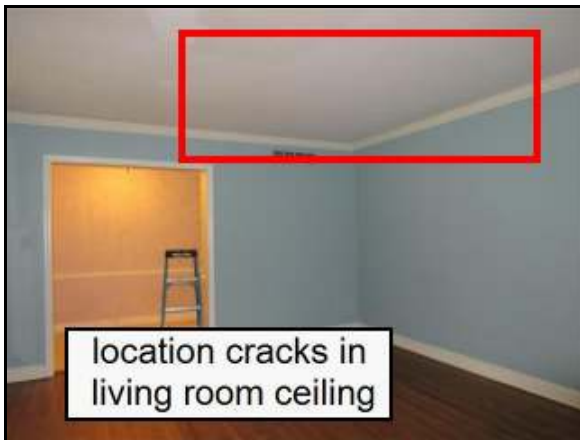
3.0 Item 1(Picture)

**3.0** Ceiling in living room and hall have cracks from someone stepping on ceiling from attic.

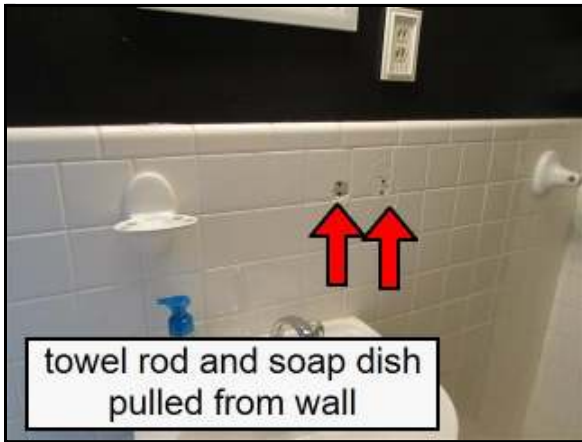
3.1 Item 1(Picture)

🏠 3.1 Towel rod holder and soap dish are pulled from wall in second floor bathroom.

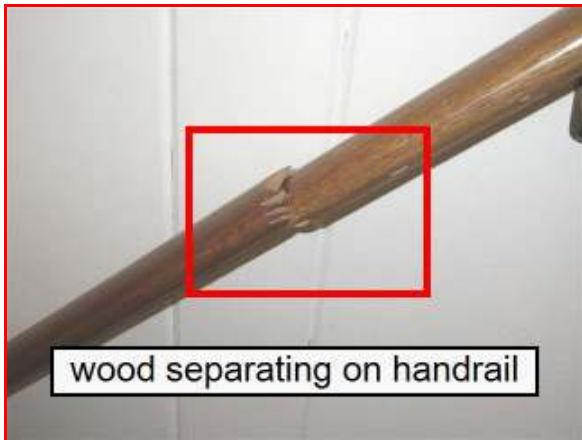
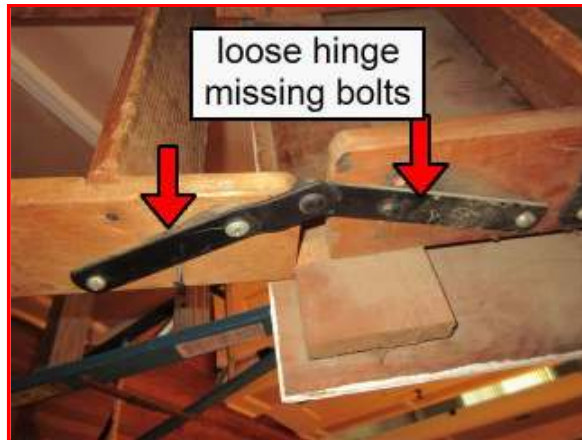
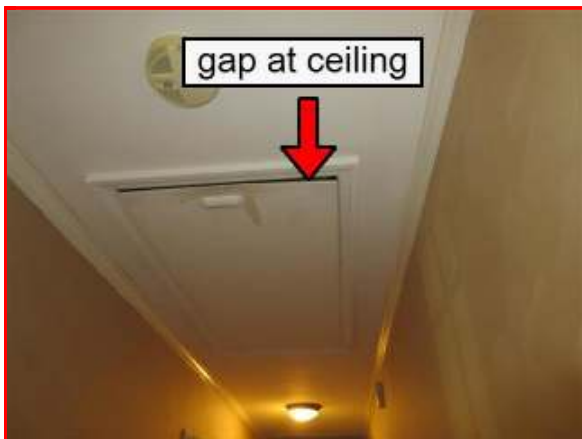
🏠 3.3 Hand railing in second floor stair well is damaged. Wood hand rail is separating.

Pull down attic stairs need repair. Hinges are loose with missing bolts. Stairs will not close completely, gap at ceiling when closed. Stairs are unsafe to climb.

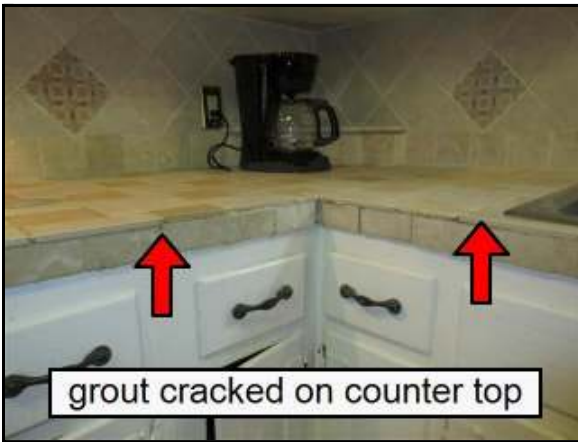
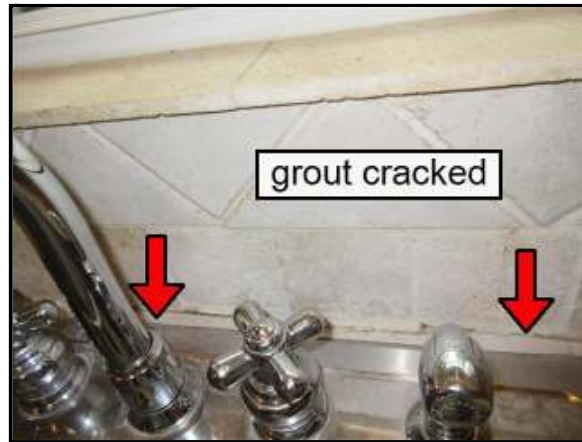
📍 **3.4** Grout is cracked on kitchen tile counter top. Hinges are sprung and kitchen cabinet doors will stay closed.

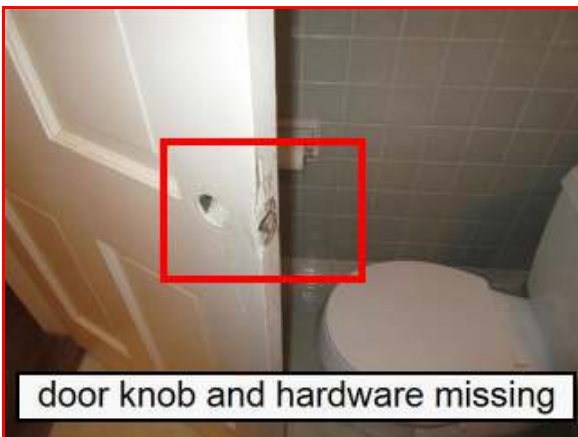
3.5 Item 1(Picture)

📍 **3.5** Door knob and hardware missing on second floor bathroom door. Hinges are not attached to wall cabinet door in second floor bathroom.

Door at top of stairs needs locking hardware installed.

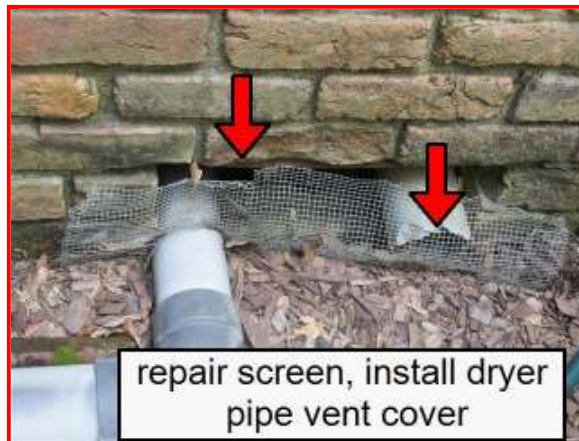
4.0 Soil is muddy under house. Rain water is penetrating foundation and accumulating under house. Lack of gutters is probably main reason for water intrusion under house. Vapor barrier is deteriorated. Recommend moisture remediator be consulted on ways to elevate water intrusion. Gutters and vapor barrier will help to keep moisture from damaging wood structure.

Water waste pipe and dryer vent pipe exit through foundation wall. Screen is pulled loose around pipes. Rodents can enter this area. Repair screen and install vent cover on dryer pipe.

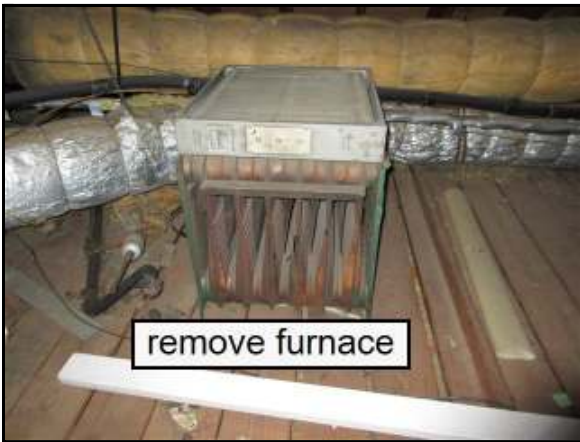
7.0 Item 1(Picture)

📍 **7.0** There is an old furnace in the attic.

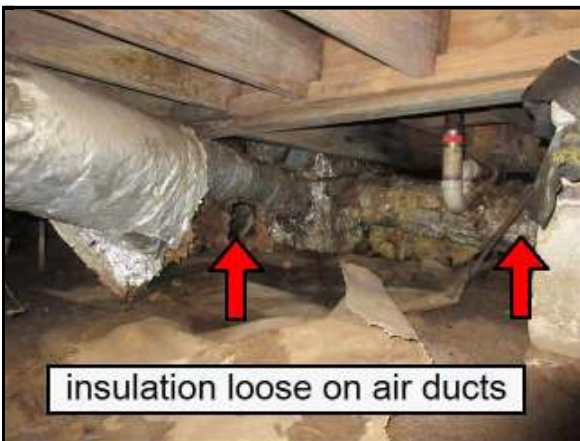
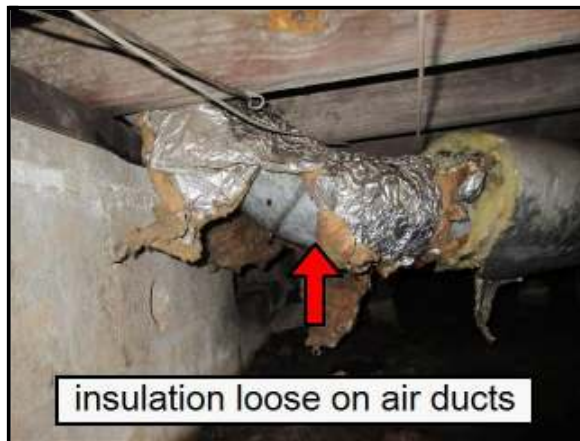
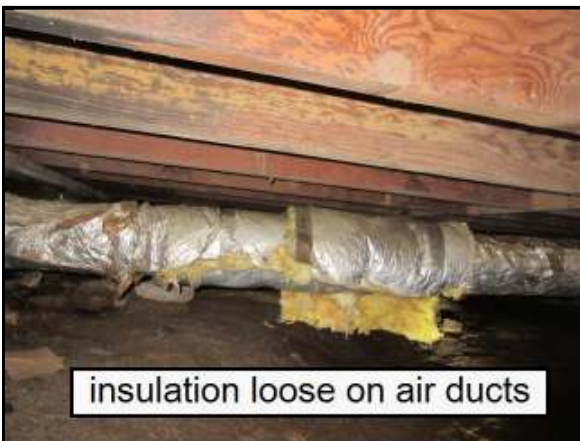
📍 **7.3** Insulation has been pulled loose in several areas of air duct under the house.

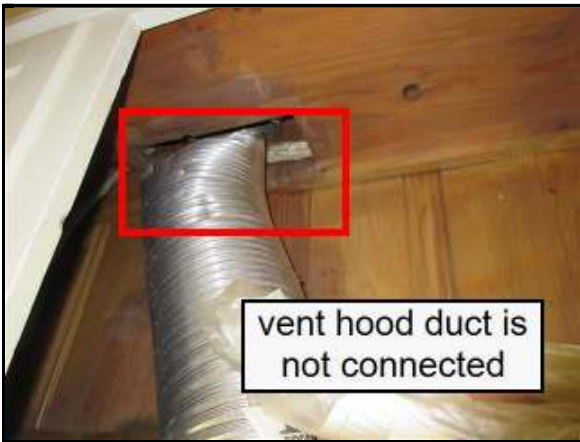
9.2 Item 1(Picture)

### 9.2 Kitchen vent hood ducting is not connected to pipe in upper cabinet.

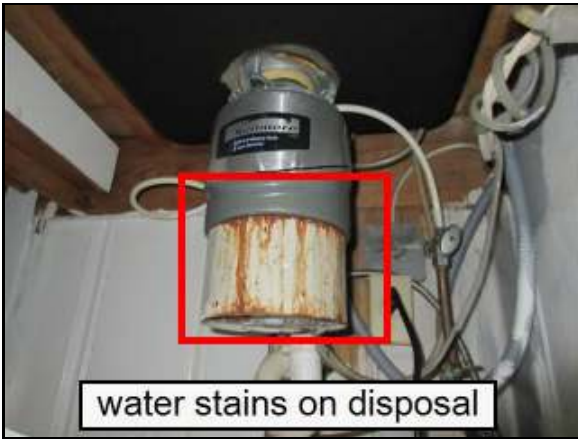
9.4 Item 1(Picture)

📍 **9.4** Disposal has debris in unit and locks up when using. Water stains on housing may be from leaks at some time when using unit.
